**Re: Los Alamos County - Los Alamos Wastewater Treatment Facility; Major; Municipal;
SIC 4952; NPDES Compliance Evaluation Inspection; NM0020141; August 15, 2017**

NPDES Compliance Inspection Report

Los Alamos County - Los Alamos Wastewater Treatment Facility
NPDES Permit Number NM0020141
Compliance Evaluation Inspection
August 15, 2017
Page 1 of 5

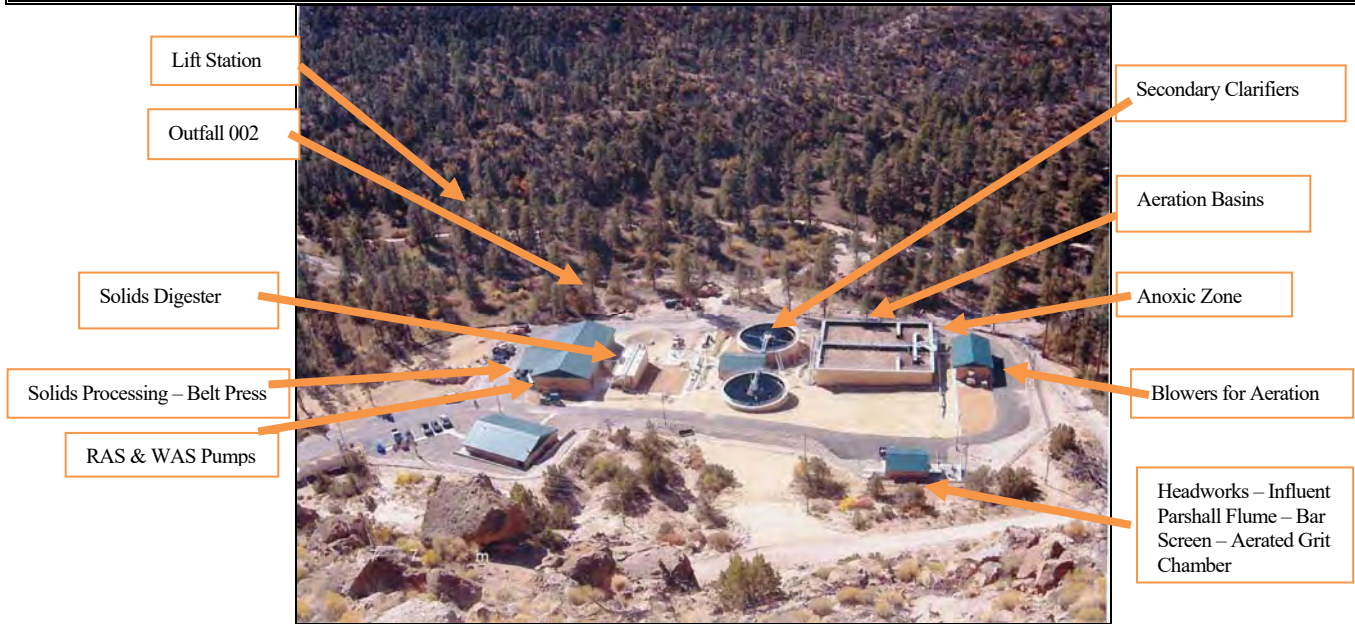
Subject: Hill side view of the new WWTP (This photo is from the previous inspection, May 4, 2012)

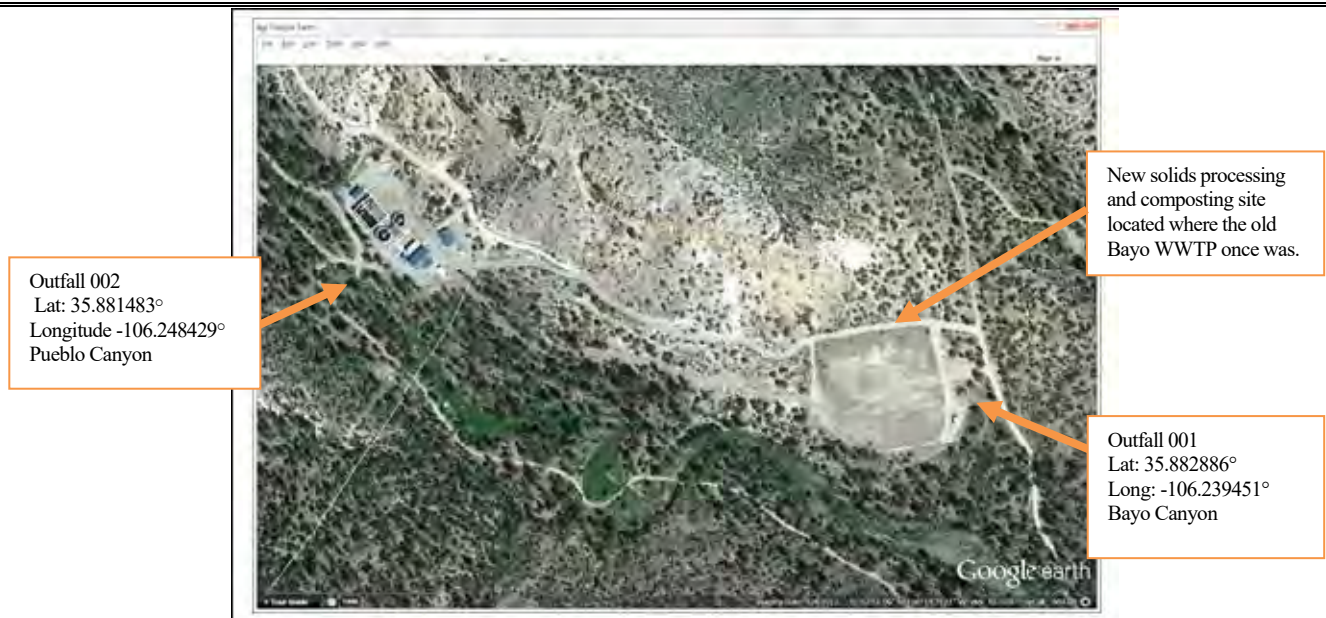
**NMED/SWQB
Official Photograph Log
Photo # 2**

Subject: 1. Location of the New WWTP and Outfall 002 to Pueblo Canyon.
2. The location of the Old Bayo WWTP is being converted to a solids and compost processing facility.
3. The location of the old outfall 001 at Bayo Canyon. (This photo is from the previous inspection, May 4, 2012)

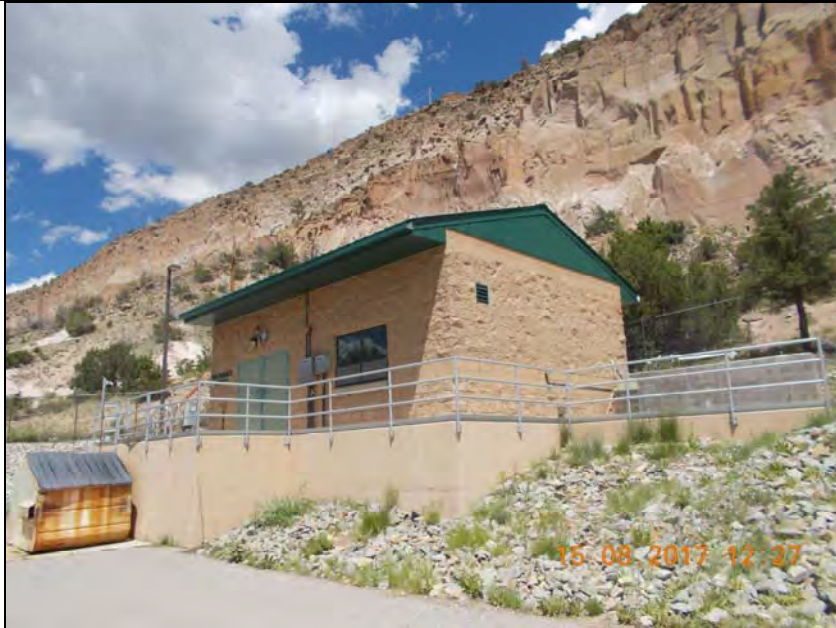
**NMED/SWQB
Official Photograph Log
Photo # 3**

Subject: Headworks building houses influent channel, primary treatment for large solids removal, and grit removal. Solids and grit are bagged and placed in the dumpster, seen in this photo, for disposal at the county landfill.

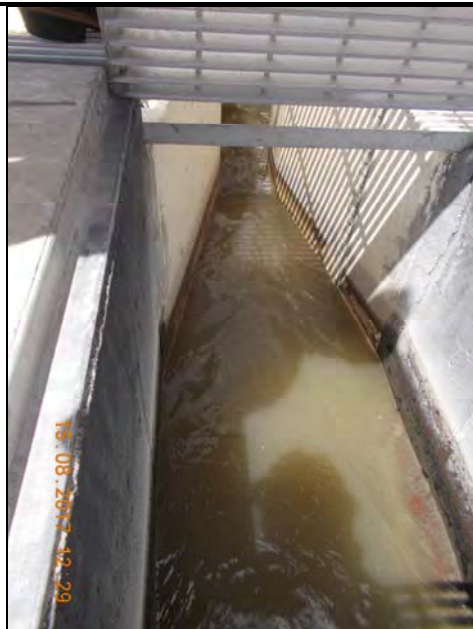
**NMED/SWQB
Official Photograph Log
Photo # 4**

Subject: Influent channel, flow measured through an 8" Parshall Flume and a totalizing meter.

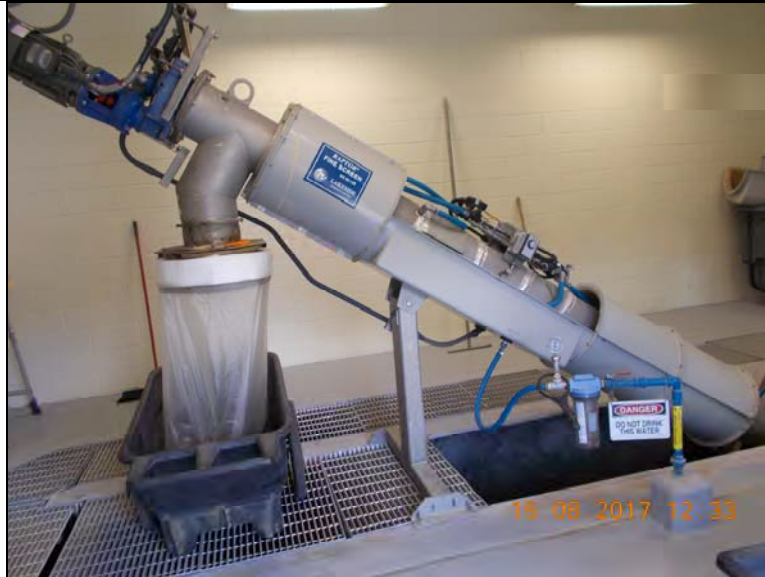
**NMED/SWQB
Official Photograph Log
Photo # 5**

Subject: Headworks and solids removal screw pump with bagging system. All solids removed from headworks are disposed of at the county landfill after passing the paint filter test.

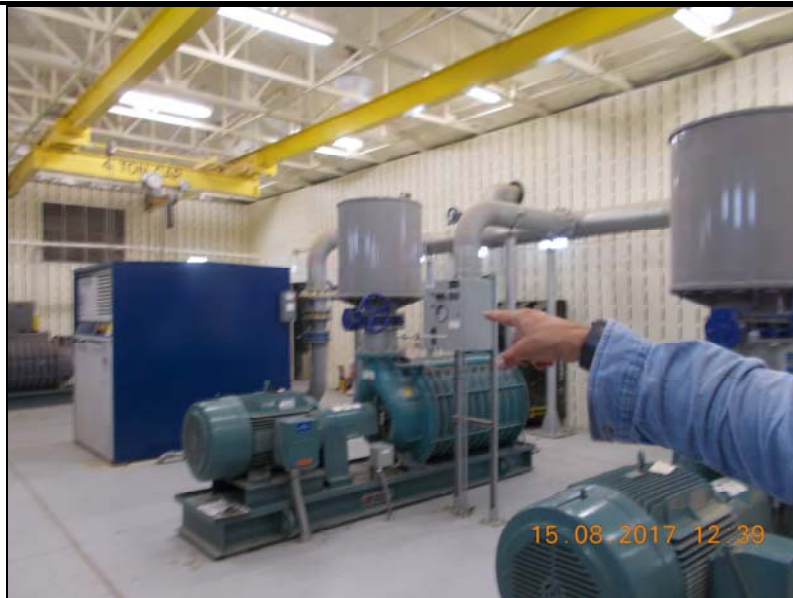
**NMED/SWQB
Official Photograph Log
Photo # 6**

Subject: One Variable Rate Blower for Aeration Basins. The other three blowers are single stage and are used in rotation during operation.

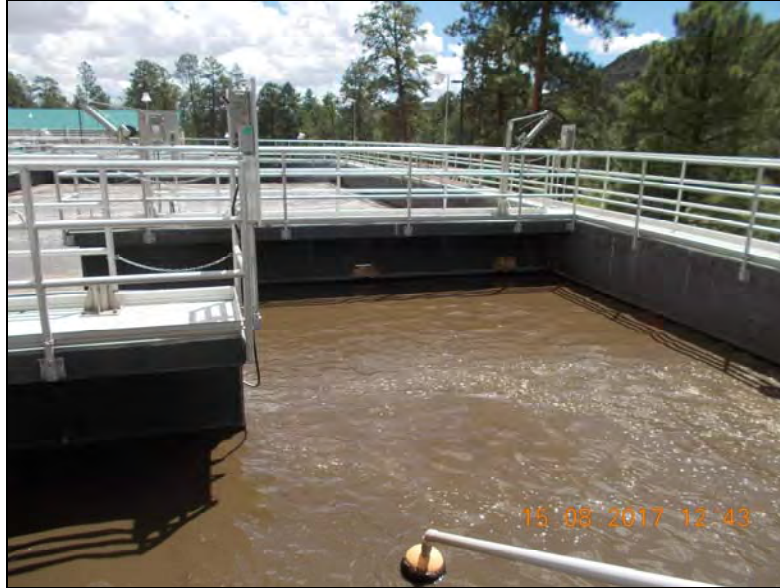
**NMED/SWQB
Official Photograph Log
Photo # 7**

Subject: Anoxic Zone – Dissolved Oxygen is maintained at 0.0 mg/L

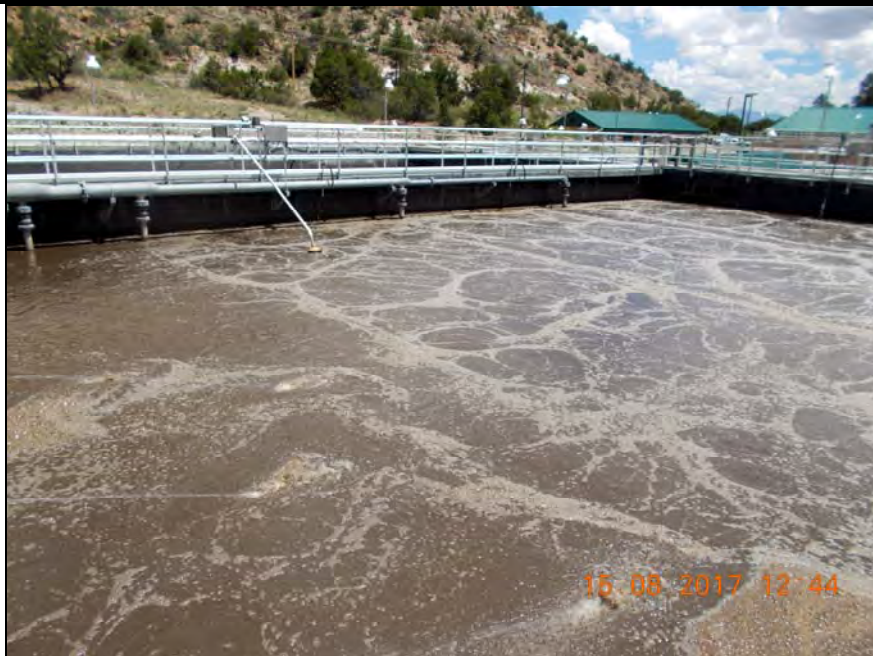
**NMED/SWQB
Official Photograph Log
Photo # 8**

Subject: Aeration Basin – the air diffuses on the bottom of the basins are effectively aerating the entire basin. There were no observable “dead spots” that would indicate a malfunctioning diffuser.

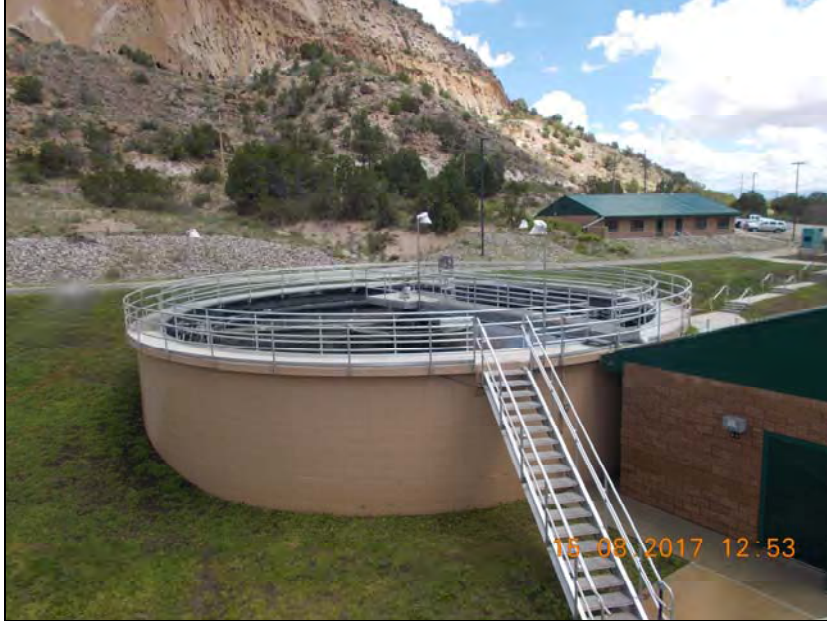
**NMED/SWQB
Official Photograph Log
Photo # 9**

Subject: one of two secondary clarifiers. Only one was in operation as the other clarifier was offline for annual cleaning and maintenance.

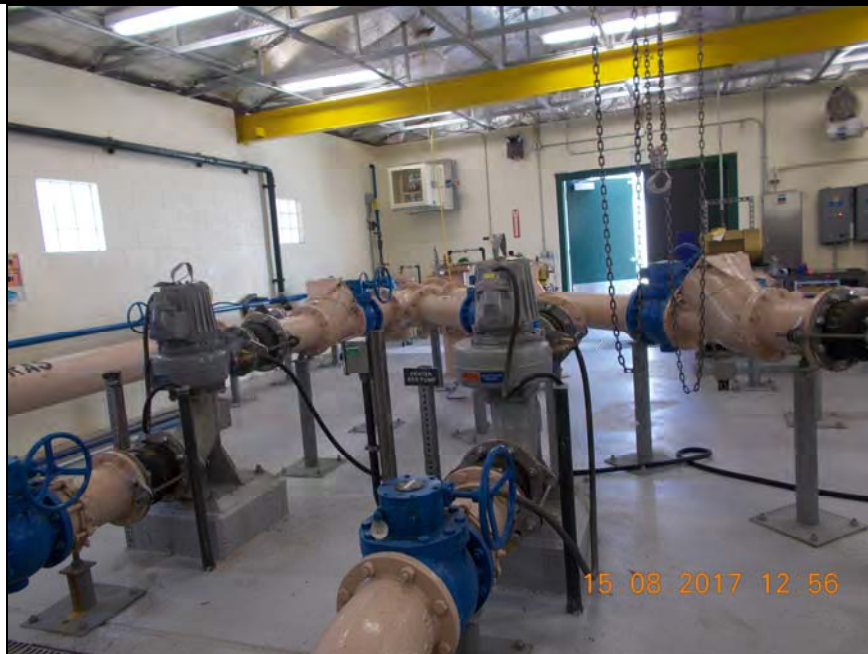
**NMED/SWQB
Official Photograph Log
Photo # 10**

Subject: Waste Activated Sludge (WAS) and Return Activated Sludge (RAS) pumps and piping following the aeration basins were maintained and operational.

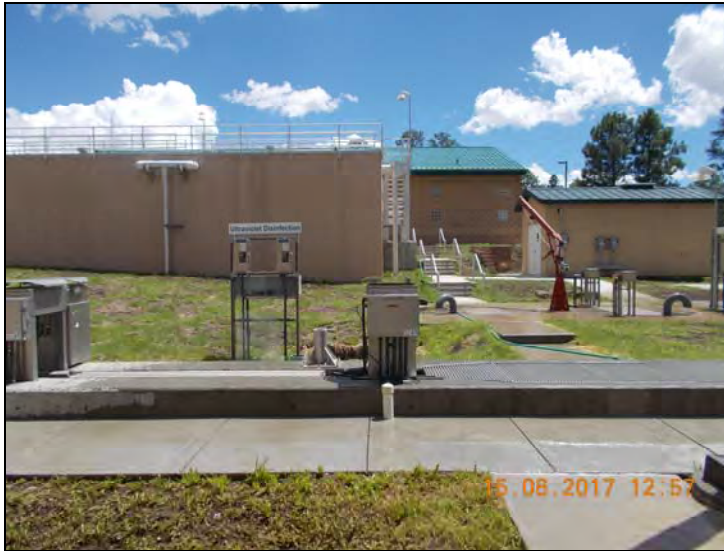
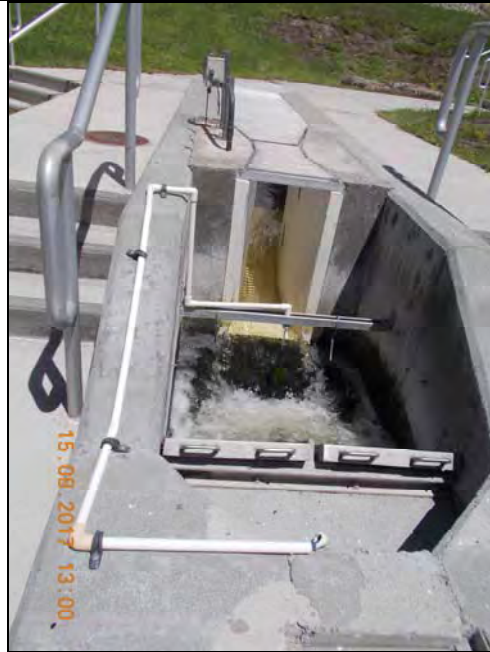
**NMED/SWQB
Official Photograph Log
Photo # 11 & 12**

Subject: Effluent flow measurement follows the Ultraviolet (UV) disinfection system. The UV system consists of two banks of lights. All systems were operating at the time of the inspection.

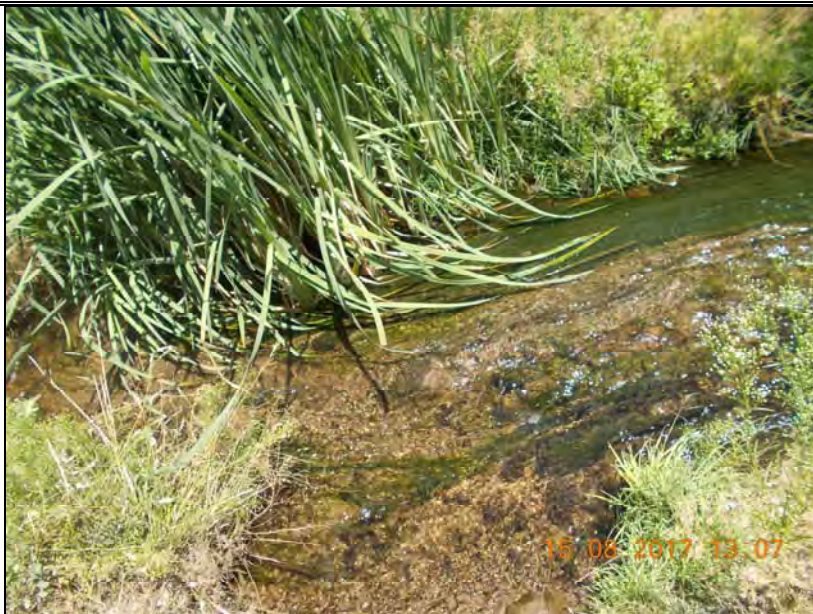
**NMED/SWQB
Official Photograph Log
Photo # 13**

Subject: Then outfall is to Pueblo Canyon. The treated wastewater was clear and free of foam and floating material. The Pueblo canyon below the outfall has riparian habitat and a wetland below the confluence with Bayo Canyon.

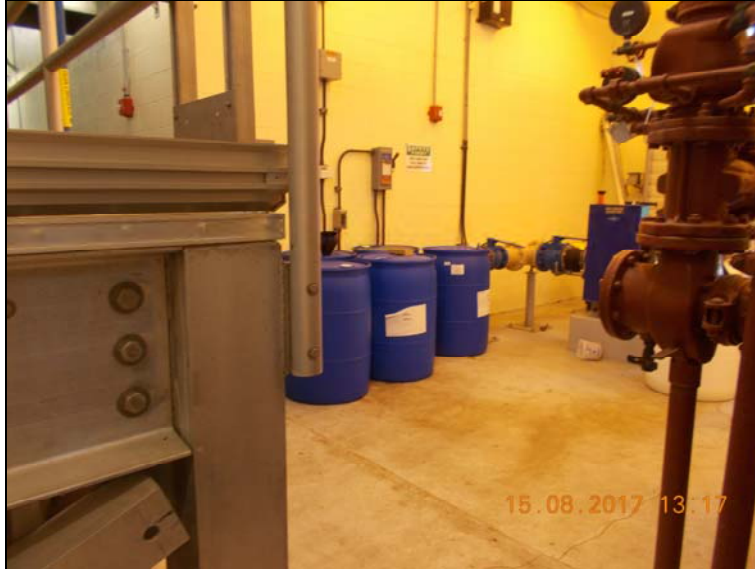
**NMED/SWQB
Official Photograph Log
Photo # 14**

Subject: The polymer used for dewatering solids are stored in the belt press building. There is no secondary containment around the barrels.

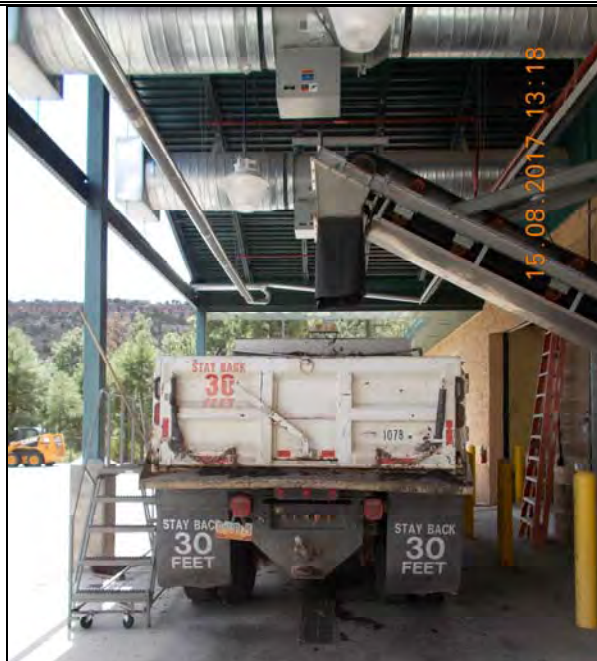
**NMED/SWQB
Official Photograph Log
Photo # 15**

Subject: Dewatered solids are transported to the composting area for processing.

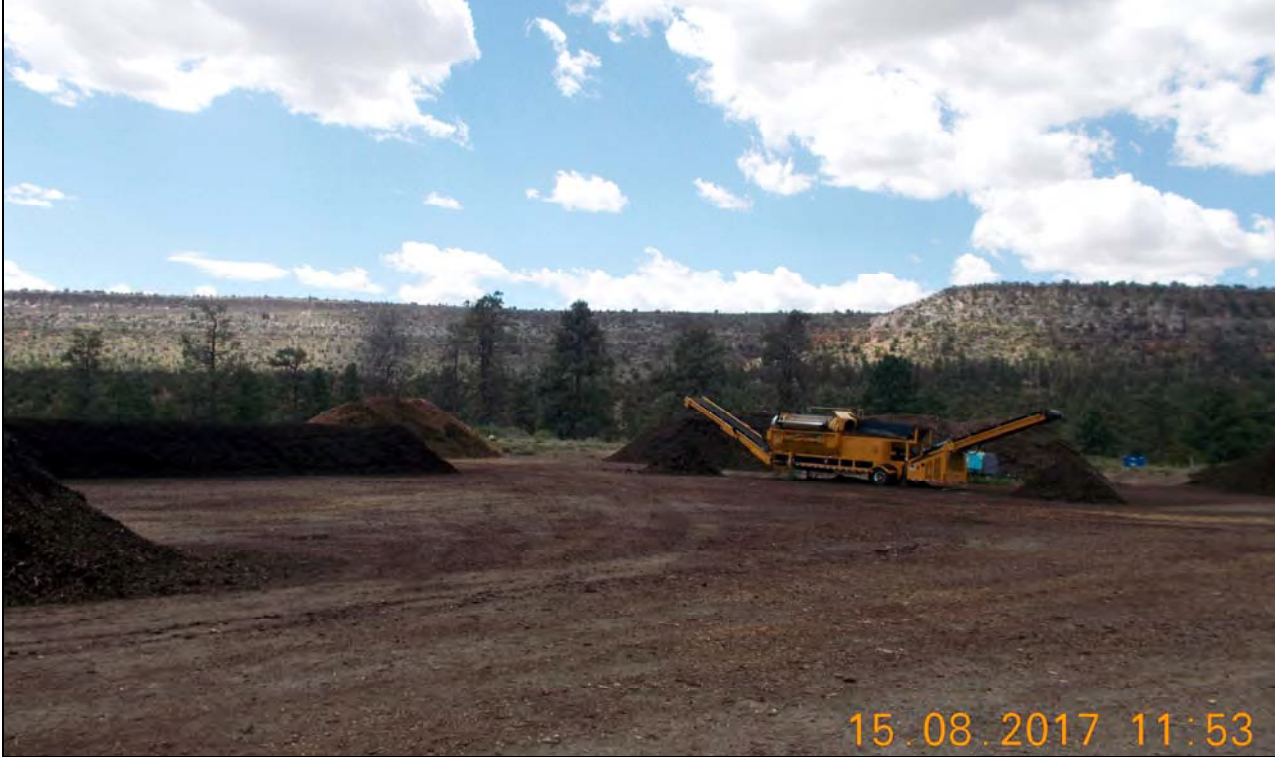
**NMED/SWQB
Official Photograph Log
Photo # 16**

Subject: The composting area is on an asphalt pad. The area is surrounded by a raised road bed that acts like a berm to prevent runoff.

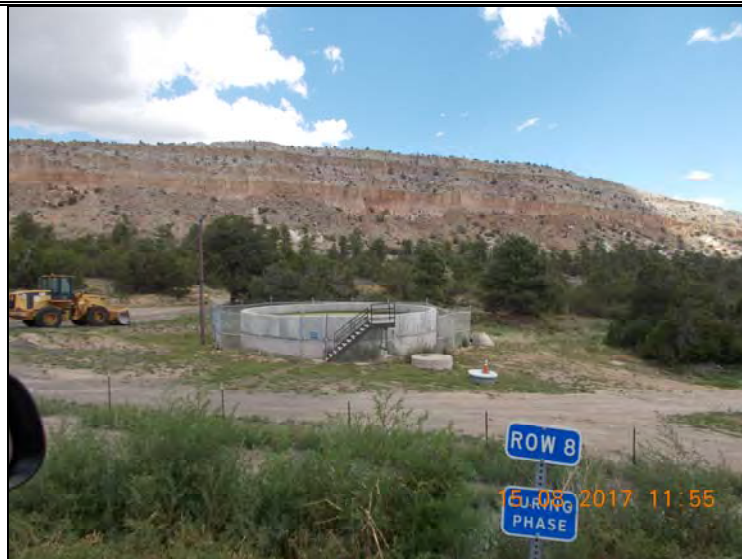
**NMED/SWQB
Official Photograph Log
Photo # 17**

Subject: Reuse holding pond. Treated wastewater is held in the pond to be pumped up to holding tanks in Los Alamos for use on parks and the golf course.

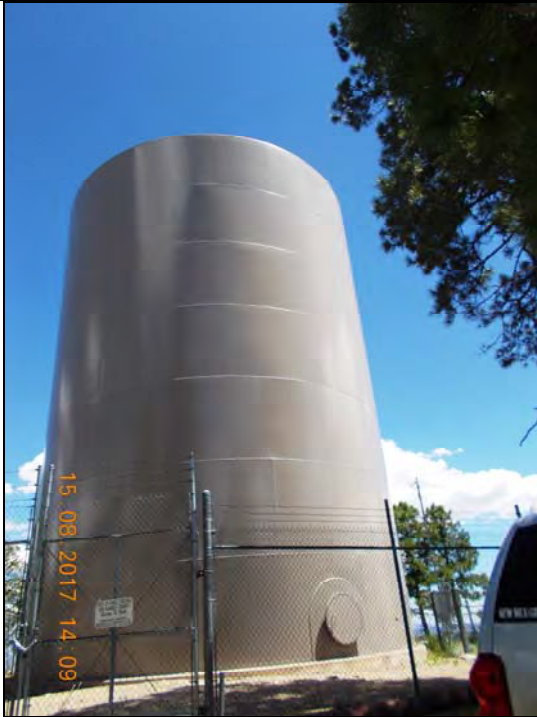
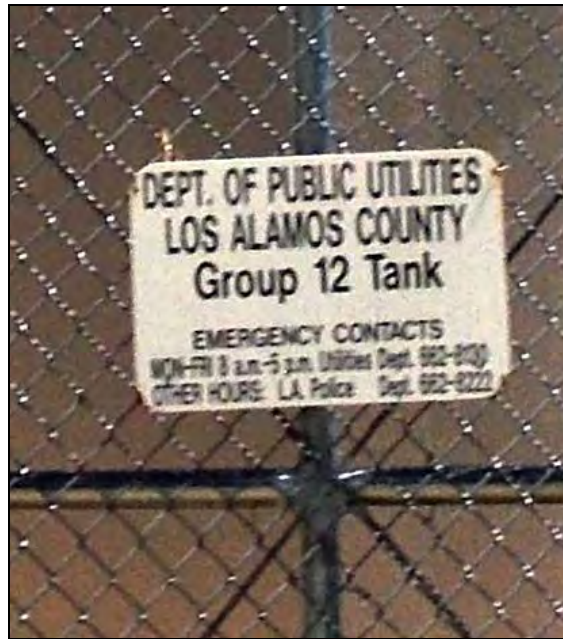
**NMED/SWQB
Official Photograph Log
Photo # 18 & 19**

Date	Location	Volume	Cause
July 28, 2017	South of Woodland Ave N of Golf Course	6,000 gallons	Leak in Welded Joint
July 4, 2017	Group 12 Tank	80,000 gallons	SCADA failure due to heat
April 30, 2017	Vacant field near soccer field	111,730 gallons	Pipeline break
March 23, 2017	Group 12 Tank	1,900 gallons	Accidental control shut off
March 14, 2017	Group 12 Tank	219,000 gallons	SCADA failure
November 6, 2016	Vacant field near soccer field	193,300 gallons	Pipe break

October 25, 2016	Group 12 Tank	70,000 gallons	SCADA failure
October 13, 2016	Group 12 Tank	39,840 gallons	
September 15, 2016	Arizona Ave & Woodland Drive	2,000 gallons	Pipe break

Subject: Reuse water is held in Group 12 Tank. This tank has overflowed because of problems with the electronic SCADA control system discharging to the Perimeter Trail.

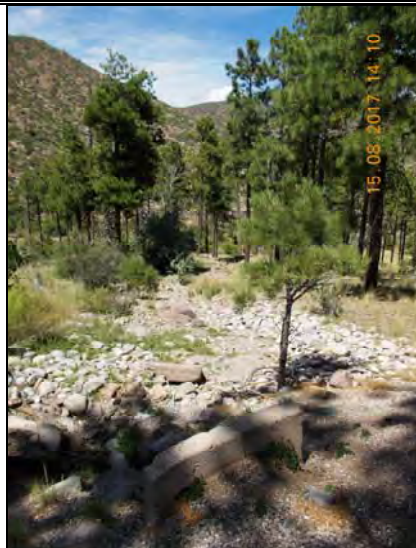
**NMED/SWQB
Official Photograph Log
Photo # 20**

Subject: Group 12 tank over flow area has been lined with rocks to reduce erosion when the tank overflows.
